Manhole Inspection Summary

Manhole # S33AA1032MH

Insp Date: **10/22/08 3:12 PM**

Location Address: **3401 SAINT PAUL ST**

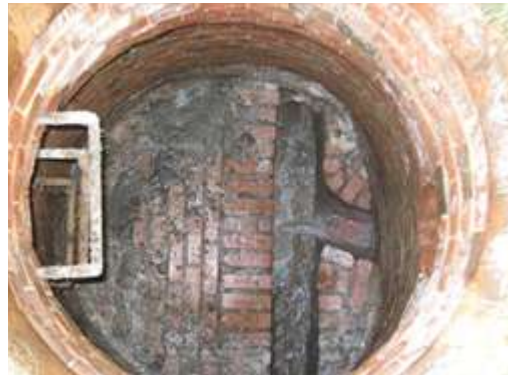
Top View

Adjustment and Barrel infiltration.
Corroded steps. Evidence of surcharge -
Bench debris.

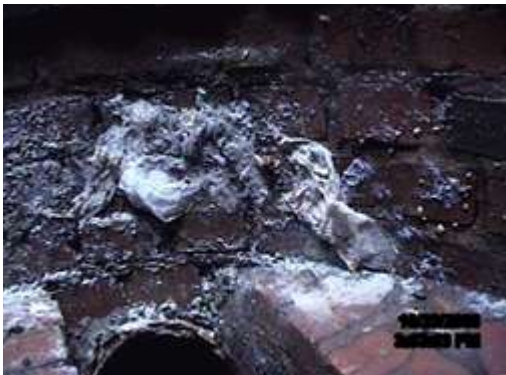
Defect

Surcharge ☒ **Evidence Of Surcharge** Depth: **1.5** (ft.) ☐ Active Surcharge Present

Evidence of surcharge.

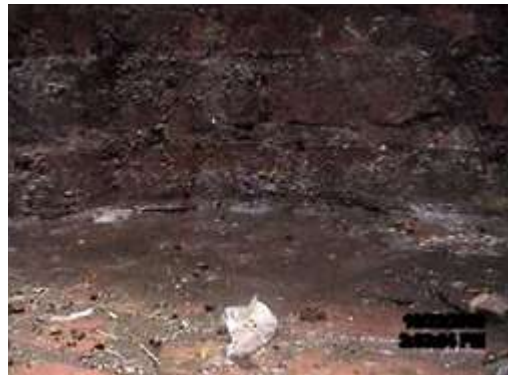
Defect

Infiltration: ☐ None ☐ Joint ☐ Cracks ☐ Mortar ☐ Roots ☒ **Wall**

Barrel infiltration.

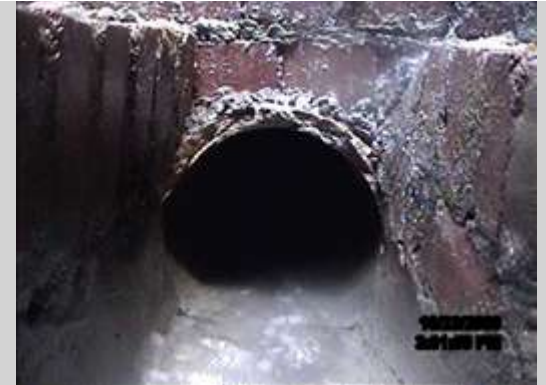
8 in. Circular Gravity Sewer Pipe Out @ 12 O'Clock

Pipe Material: **Clay** ☐ Pipe Lined

Invert Depth: **8.00** (ft.) Flow Characteristics: **Fast**

Deposits: ☒ None ☐ Mud ☐ Sludge ☐ Debris ☐ Grease

Infiltration: **None** Pipe Seal Cond: **Unknown**

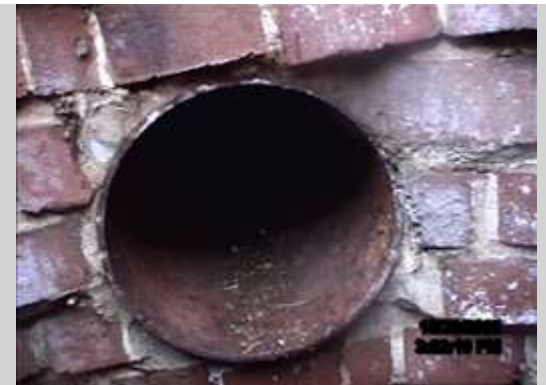
8 in. Circular Gravity Sewer Pipe In @ 3 O'Clock

Pipe Material: **Clay** ☐ Pipe Lined

Invert Depth: **2.70** (ft.) Flow Characteristics: **Fast**

Deposits: ☒ None ☐ Mud ☐ Sludge ☐ Debris ☐ Grease

Infiltration: **None** Pipe Seal Cond: **Unknown**

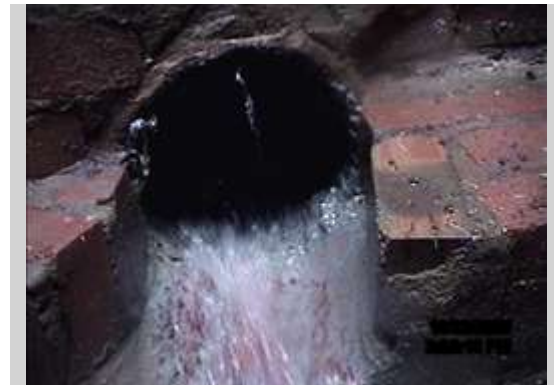
Drop In @ 3 O'Clock

Drop: **Outside** Rod and Bar
Angled: **Yes** Reading: **6.48** (ft.)
Inv Depth: **7.48** (ft.)

Drop Condition: **Open**

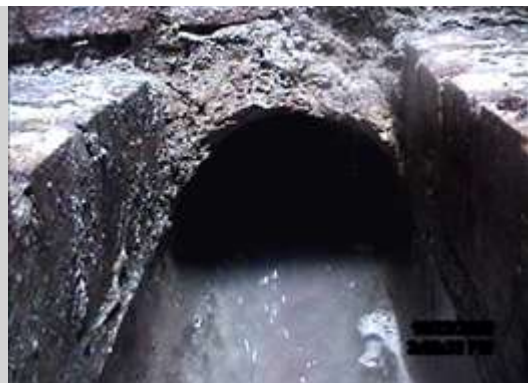
Pipe In @ 6 O'Clock

Pipe Material: **Clay**

Invert Depth: **7.98** (ft.) Flow Characteristics: **Fast**

Deposits: ☒ None ☐ Mud ☐ Sludge ☐ Debris ☐ Grease

Infiltration: **None**
